# Evaluating Urban Ecological Infrastructure for Stormwater Management in Phoenix, AZ

Kayla Tarr, Mikhail Chester, Daniel L. Childers, Abigail York  
 Central Arizona-Phoenix LTER, Arizona State University

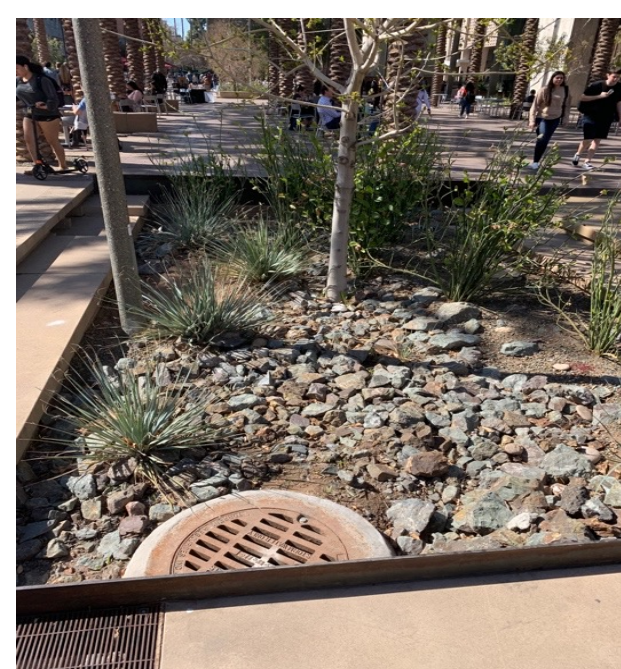
**Fig. 3.** Example of Orange Mall bioswale

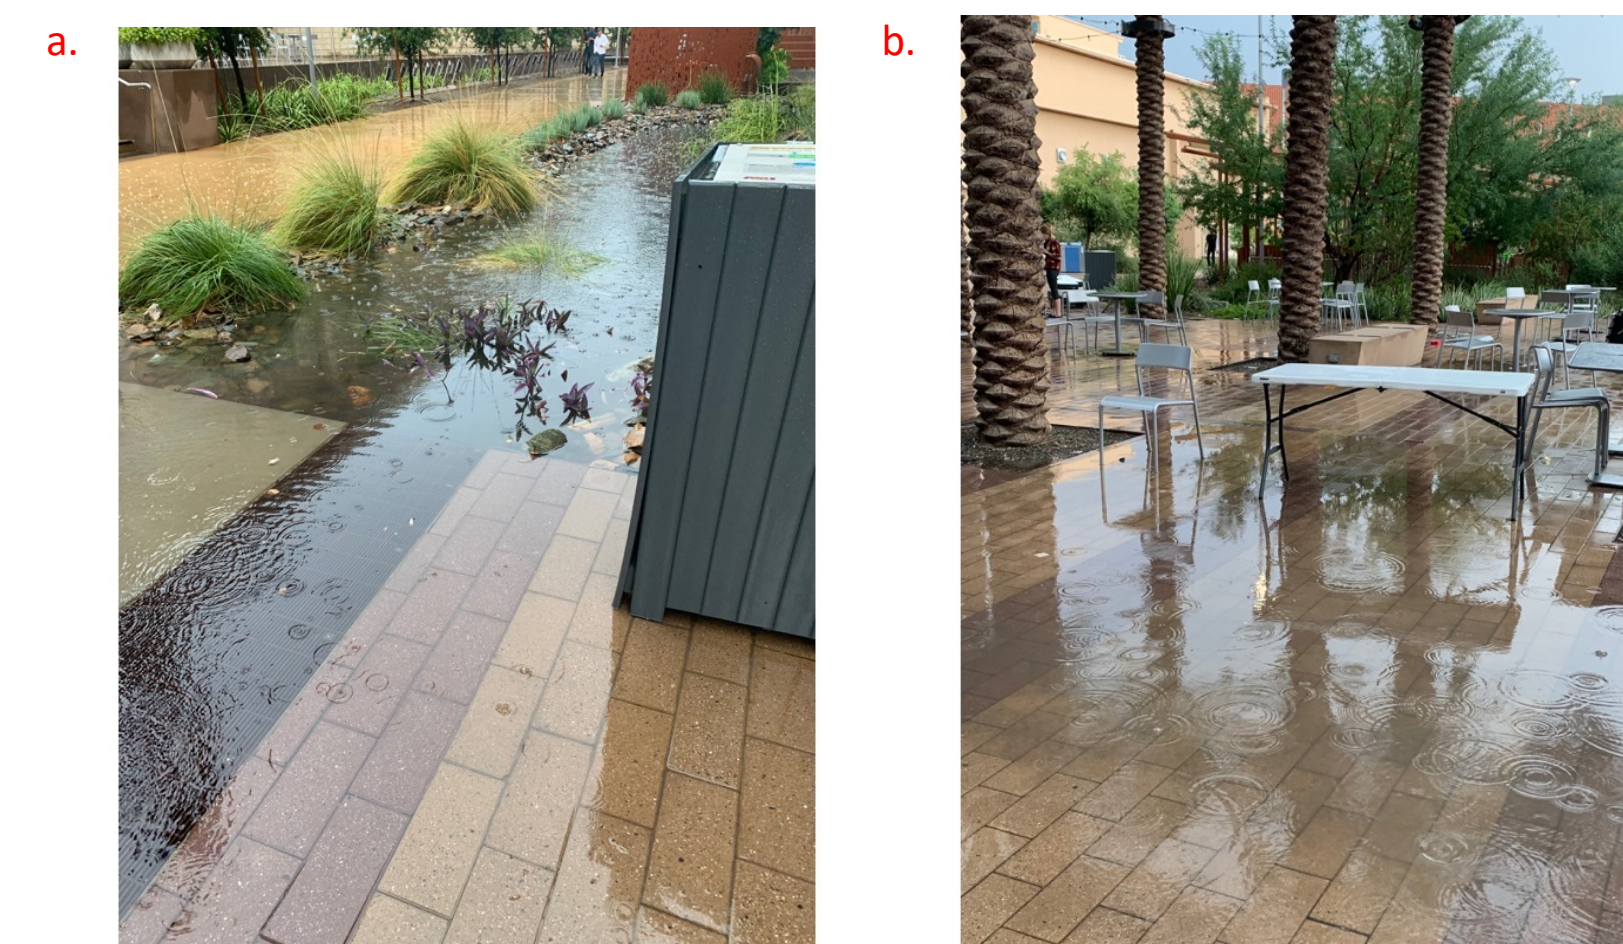
**Fig. 6.** a) Overflowing basin after heavy precipitation events from July 24-26, 2021. b) Example of water accumulating on impervious surfaces in Orange Mall.

In addition to collecting data, we have also noted some important observations about the design of the bioswales and how they contribute to various ecosystem services. While we have not yet collected data on these observations, they nonetheless serve as important starting points for further development of the lead author's Ph.D. research as well as potential avenues for other researchers. The most notable observation we have made is the capacity of various basins, especially in the event of particularly heavy and/or persistent precipitation. One specific basin – located adjacent to the Student Pavilion on the west side – has overflowed on multiple occasions (see Fig. 5 below). Further, although the bioswales break up the impervious surfaces on Orange Mall, the area is still paved. Puddles of water can be noted in the area after a storm event. The area and the bioswales do not have to be designed to withstand any amount of precipitation, but these observations do raise questions about if the design is effective.
