Measuring bedrock topography using gravity to understand subsidence along a portion of the CAP canal in northeast Scottsdale.

¹Paul A. Ivanich, James A. Tyburczy, J Ramón Arrowsmith, Mimi Díaz. Department of Geological Sciences, Arizona State University, PO Box 871404, Tempe AZ 85287-1404.
¹paul.ivanich@asu.edu.

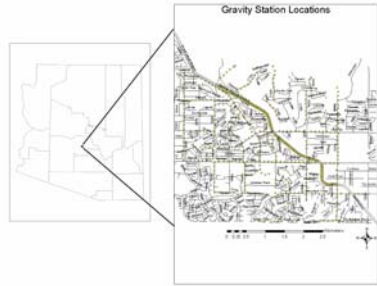
Figure 1: Study area with gravity station locations plotted. 540 gravity stations were established, with 100-meter spacings along the streets and 50-meter spacings along the canal (both sides).

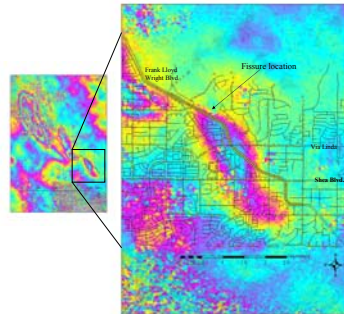
Figure 3:

These InSAR images show surface displacement and are therefore good tools for imaging subsidence. Each color cycle in these InSAR images (from green through the color cycle to green again) represents 2.8 cm of vertical displacement. The images span 1330 days from 1996-2000. Independent surveying done along the CAP canal shows maximum subsidence of 1.5 feet at the Via Linda bridge since canal construction (late 1980s).

The figure at left shows the subsidence features that exist near the McDowell Mountain front in Scottsdale, AZ. These ellipsoid features trend generally the same direction (N35W to N50W). Their similar trends and shapes could indicate a large scale structural (bedrock) control on subsidence in this area.

The Pool 24 feature is shown at right. An earth fissure has formed in the vicinity of the Cactus bridge, and indicates a steep drop-off in the bedrock/alluvium interface (see Figure 7). The InSAR image shows a high subsidence gradient in that area (green to blue in a short distance).

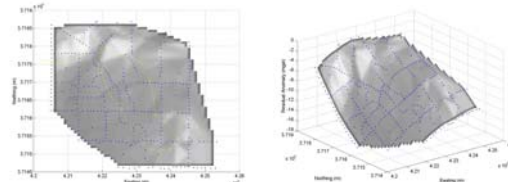
Figure 4:

Surface of the residual gravity anomaly. The residual anomaly is the result of variations in the near-surface geology. The figure on the left shows the location of the Pool 24 subsidence bowl (shown in yellow for reference). The figure on the right shows the residual anomaly surface. To the east, the residual is relatively flat, and it begins to drop off close to the boundary of the InSAR bowl. See Figure 3 for reference locations. (Plots produced in Matlab.)

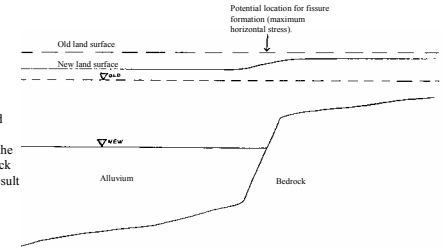
Figure 7:

Schematic drawing of bedrock controlled subsidence, which could produce the observed subsidence feature and the earth fissure. The bedrock structure could be the result of faulting or bedrock paleo-topography.

Differential subsidence produces horizontal stress in the alluvium. When the magnitude of the stress is high enough, horizontal strain and tensile failure occurs, resulting in the formation of an earth fissure. See Figure 7
